Disturbance Measurements from Off-Road Vehicles on Seasonal Terrain

Rosa T. Affleck

July 2005

Final report

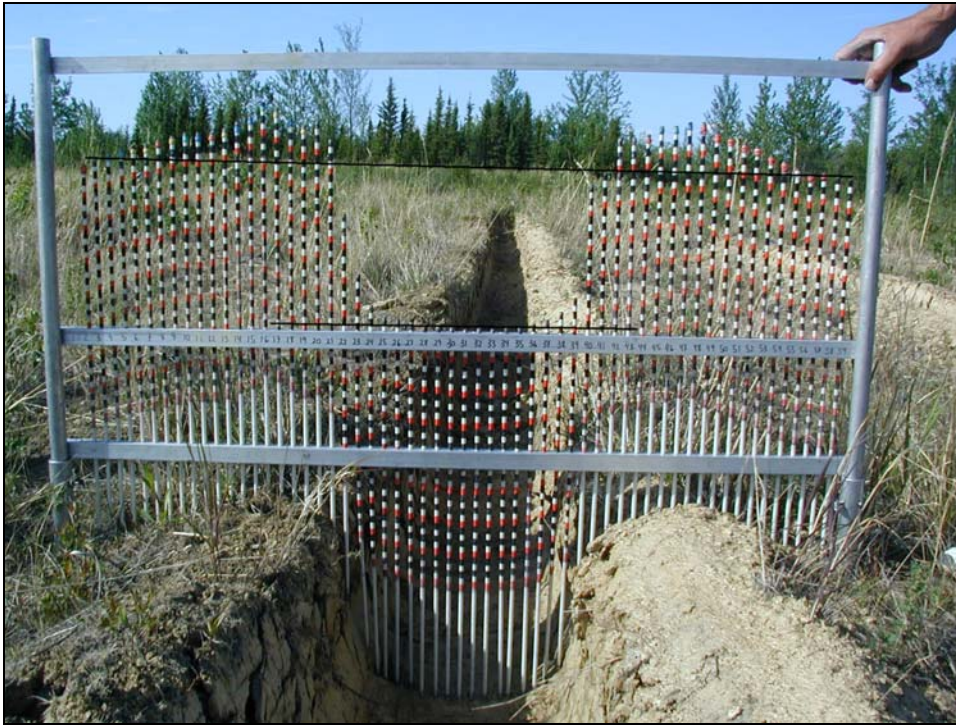
Figure 3. Rut depth measurement and determination using a profilometer.

Rut depth is the distance measured between the bottom of the tire track that has been caused by vehicle traffic and the adjacent undisturbed soil surface. Rut depth is typically measured with a profilometer, which is placed in the center of the tracks, and depths. This was the technique used at Fort McCoy and DTA. However, more detailed rut depth data were collected from the maneuver impact tests at DTA using a profilometer made of a metal bar with sliding rods as shown in Figure 3. The rods are spaced every 2 cm horizontally and each rod is marked at 1-cm intervals vertically. The profilometer was placed in the center of the rut and a photo of the rut depth taken, and its location noted using a GPS unit. The photos were printed and lines were drawn of the natural (undisturbed) ground surface profile (the outside of the ruts) and maximum level of the rut. Rut depth is determined by counting the 1-cm intervals on the rod between the surface and rut lines (Fig. 3).

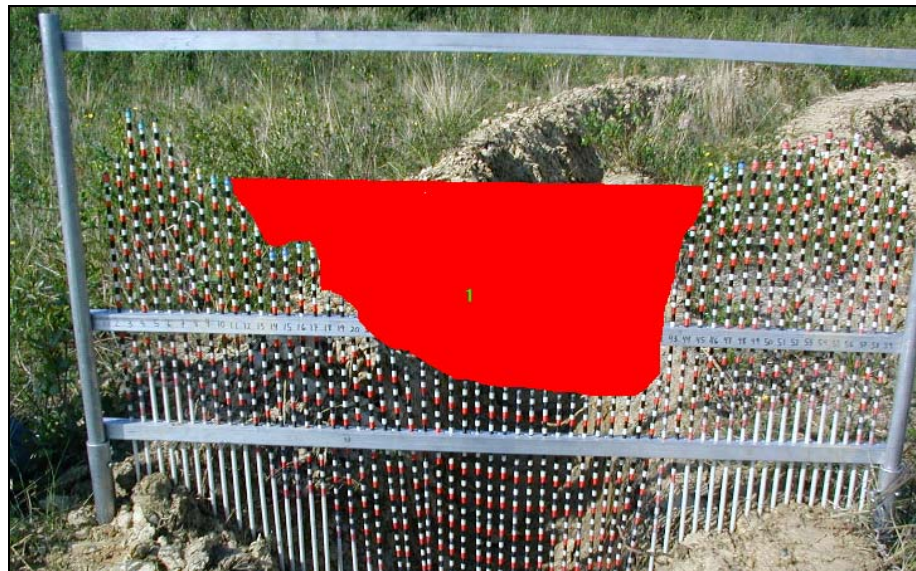
Figure 5. Soil displacement calculation using image processing software to determine the area of a rut.

A method to calculate the volume of deformation (rutting) can be achieved using the rut depth measurements from a profilometer. Using the picture file of rut depth data, the soil displacement or deformation area of the rut can be calculated using image processing software (Image Pro Plus). The area is determined using the correct scale of the profilometer from the rod increments and spacing in centimeters, then tracing the enclosed area of the rut and counting the number of pixels inside it (Fig. 5). Using a conservative assumption that soil being displaced is uniform within 1 m of track length, the volumetric displacement is computed by multiplying the area of soil displaced by 100 cm of track length.

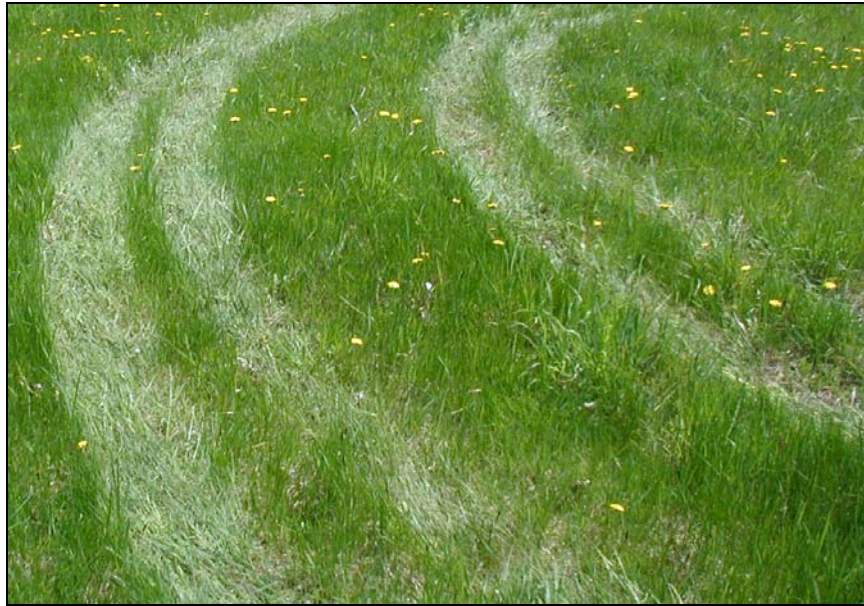
a. Example of imprint disturbance.

b. Example of a combination of pile and scrape disturbances.

Figure 6. Disturbance categories used to determine impact severity.

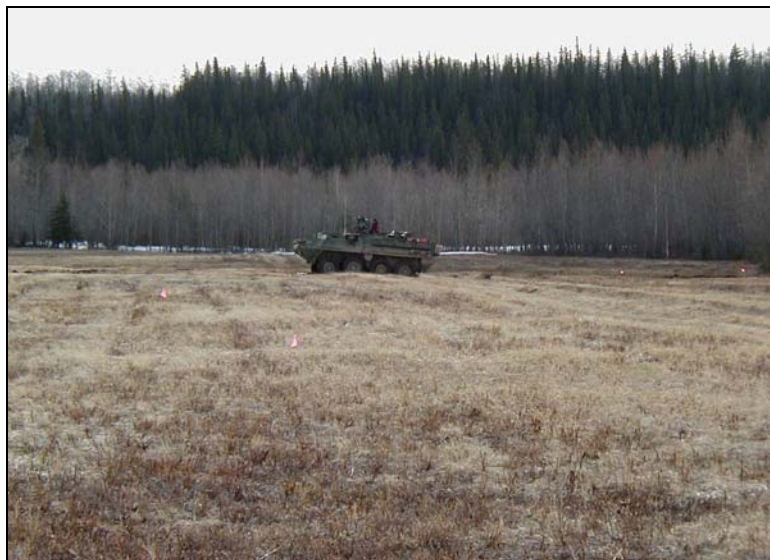
a. Vegetation features.

b. Pattern of maneuver impact test.

Figure 10. Photo and map of terrain at Arkansas Range showing vegetation features and pattern of maneuver impact test: spiral section and multi-pass section, with arrows indicating direction of vehicle travel (May 2003).

The vegetation is composed of grass and short bushes, and was previously mowed in the fall (Fig. 10a). Figure 10b is a map of the GPS tracks, showing the maneuver pattern overlying the ortho-photo. The thirteen-pass test section was located near the tree line, as seen on a map of the maneuver pattern (Fig. 10b). Big roots from the trees were visible on the surface in some areas. The spiral section and the easternmost portion of the multi-pass area were very wet, with surface water ponding; however, the rest of the multi-pass section was fairly dry.

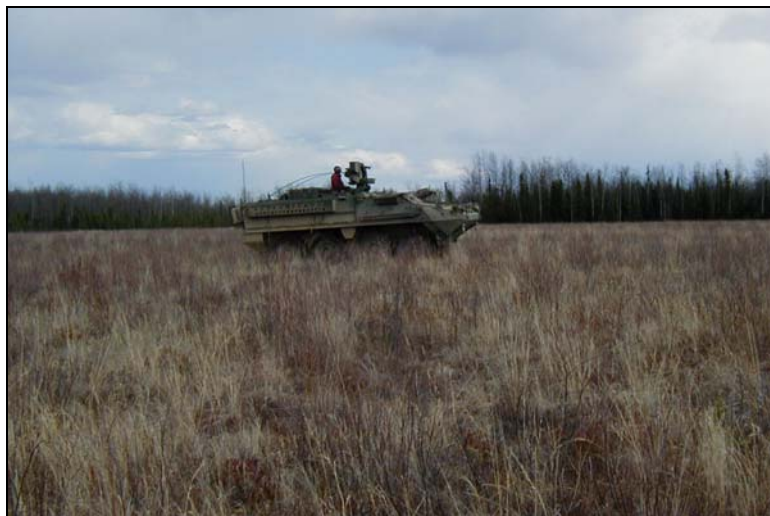
a. Vegetation features.

b. Pattern of maneuver impact test.

Figure 12. Photo and map of terrain at Eddy Drop Zone showing vegetation features and pattern of maneuver impact test: the spiral section, and the multi-pass section with arrows showing the direction of vehicle travel (May 2003).

The vegetation is composed of sphagnum moss, sedge, tall grass, and thick bushes up to 1 m (3.5 ft) tall (Fig. 12a). A GIS map with the GPS points tracks maneuver pattern for the multi-pass and spiral test sections is shown over the ortho-photo in Figure 12b. (The vegetation appears as a darker gray on the map.)

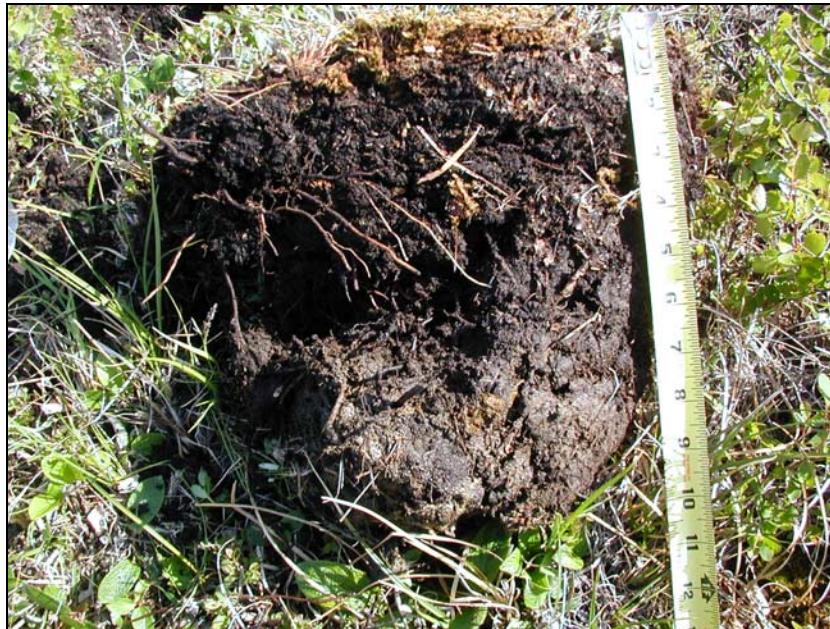
Figure 13. Highly organic material located at the Texas Range maneuver site.

Texas Range. This site is an alpine tundra area with an ecological land classification of lowland tussock scrub bog on gently sloping permafrost terrain. The active layer was mostly frozen during the maneuver tests. The soil is described as glacial loess and moraine deposits with very high organics content. The material is characterized as peat as shown in Figure 13.

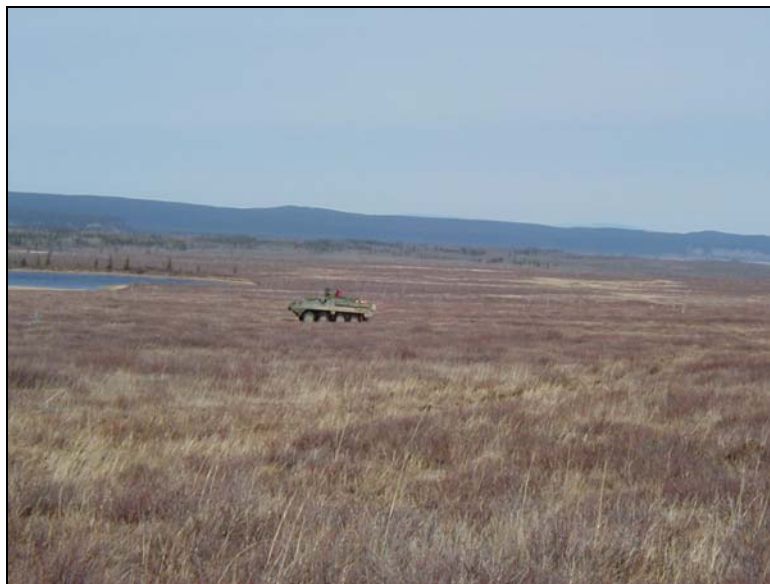
a. Vegetation features.

b. Pattern of maneuver impact test.

The vegetation is composed of sphagnum moss, sedge, grass, and shrub (Fig. 14a). Only the spiral maneuver test, shown in Figure 14b, was conducted at this site because the Stryker vehicle was available only for a limited time.

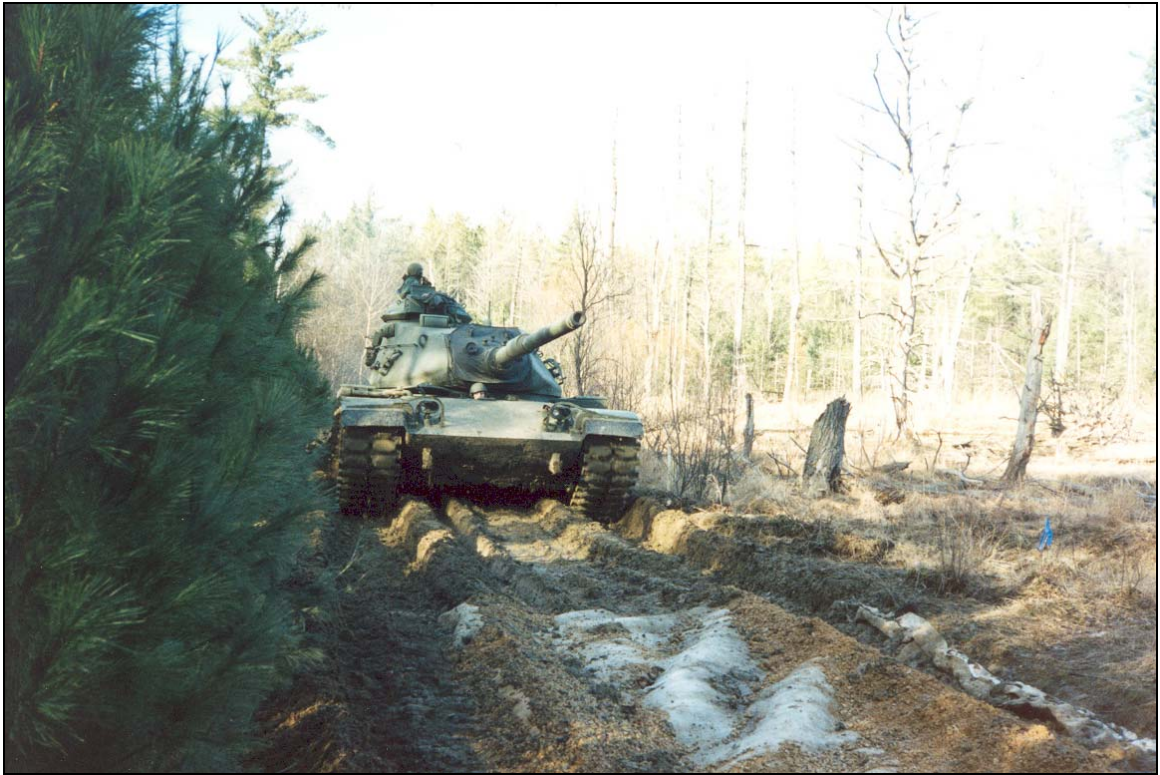
Figure 16. Control section of the wooded trail at Fort McCoy trafficked by an M60A3 in April 1995.

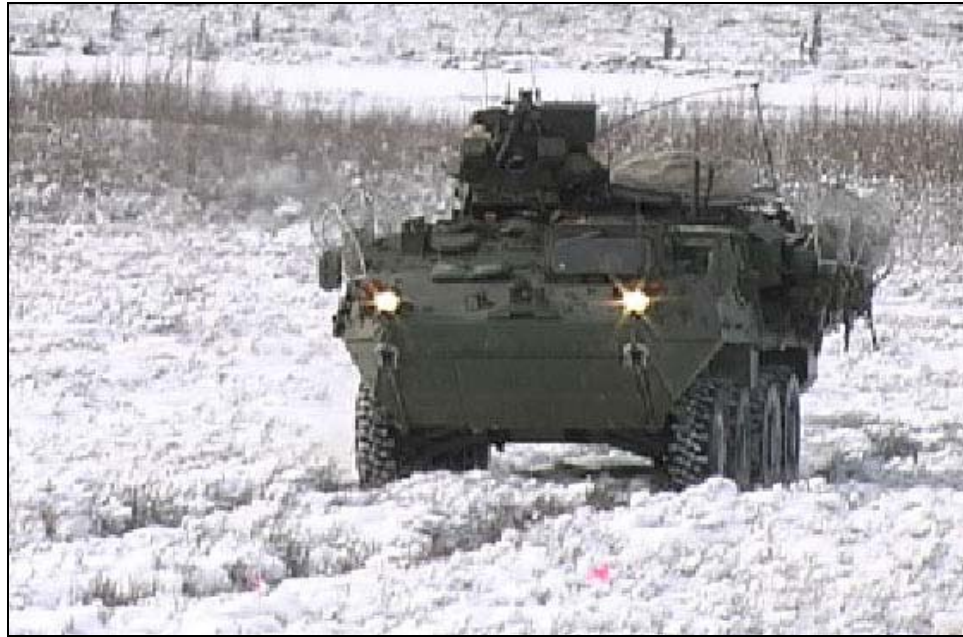
Figure 17. Stryker disturbance test in March 2003 at the Texas Range.

A disturbance test was conducted using the Stryker vehicle in March 2003 as shown in Figure 17. Both multi-pass and spiral tests were performed. The test was located on the southwest area of the spiral section in May at the Texas Range shown in Figure 14. Snow depth during the test was very shallow, approximately 10 cm (4 in.). Snow density was not recorded. The site had no snow cover in February and the winter was considerably mild for the area, as noted in Section 4.2.1. The ground was observed to be frozen. As stated in Section 4.3, the terrain at the Texas Range is on permafrost. However, the depth of permafrost was not determined for this test. The active layer is assumed to be frozen all the way to the permafrost.

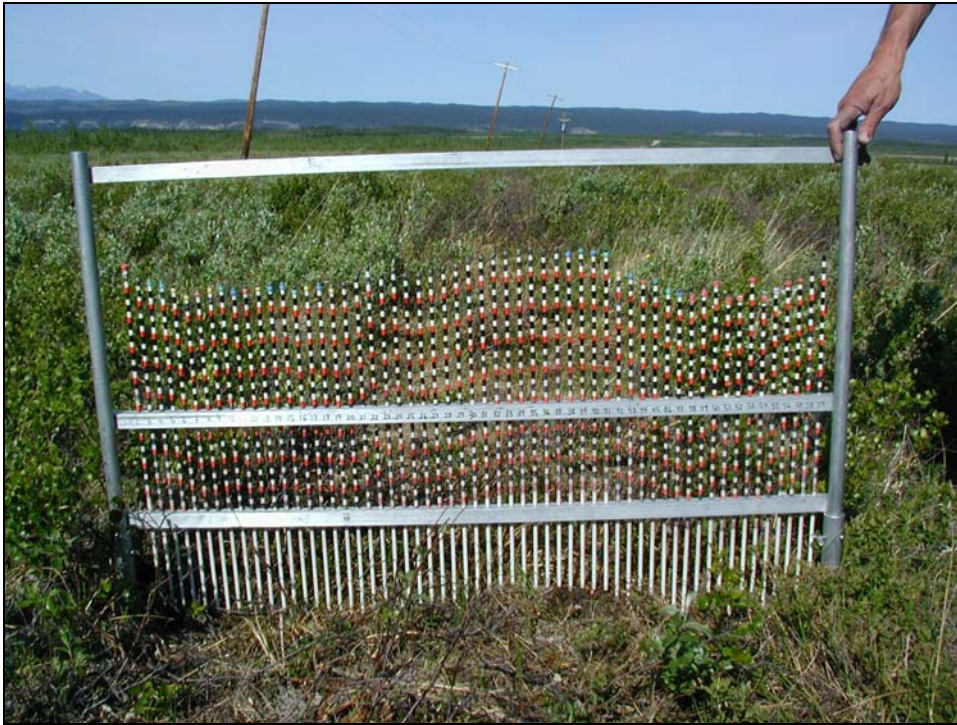
Figure 30. Minor vegetation disturbance and no measurable rut depth resulted from the winter disturbance test.

There were no measurable ruts at both the multi-pass and spiral section during the winter disturbance test. Figure 30 is a rut profile at the thirteen-pass section of the multi-pass section. The impact severity of 10% resulted from the survey showing the track imprint with vegetation roots still intact, laying down of vegetation, and few broken branches.

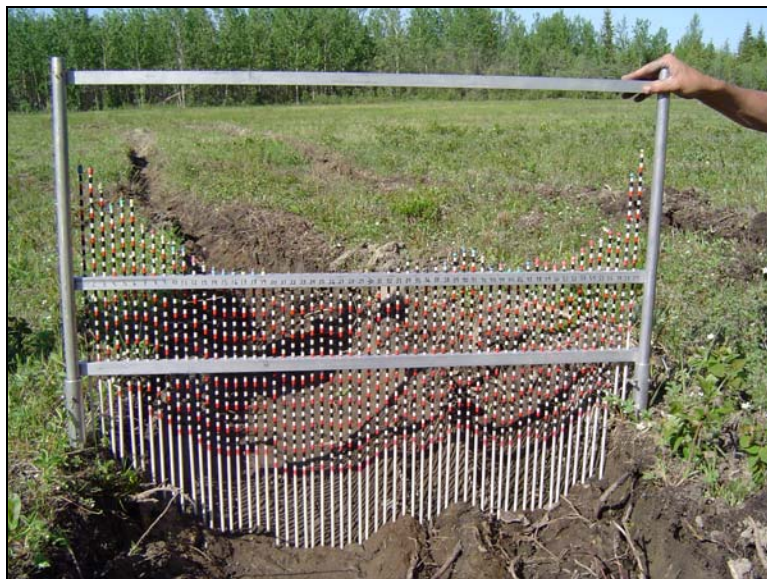
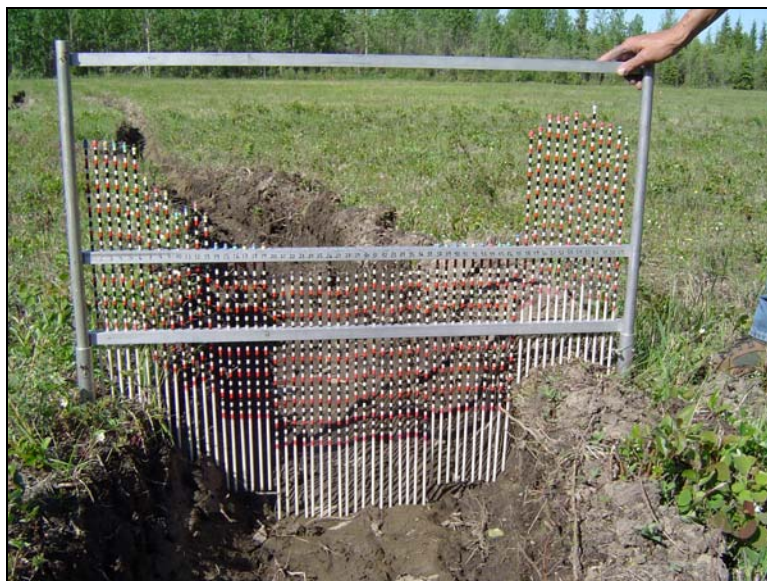
a. Left track.

b. Right track.

Figure A1. Rut profiles on point A13H on turn section of thirteen-pass at the Arkansas Range.

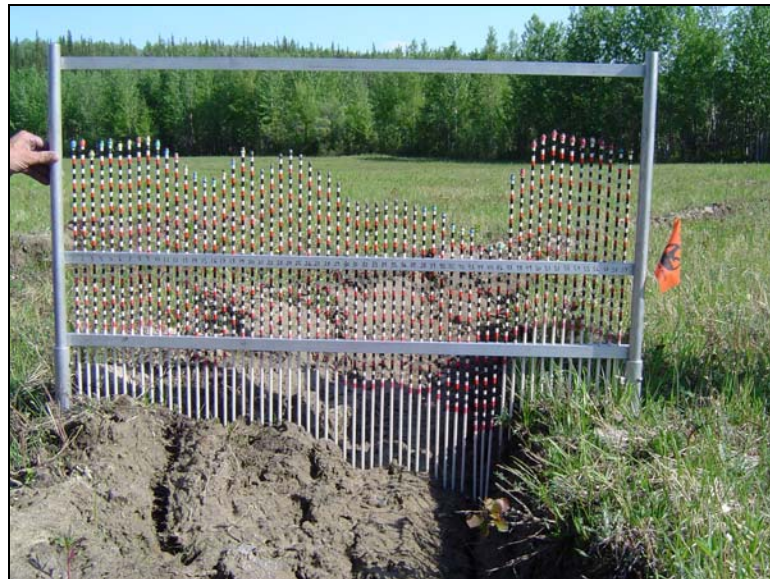
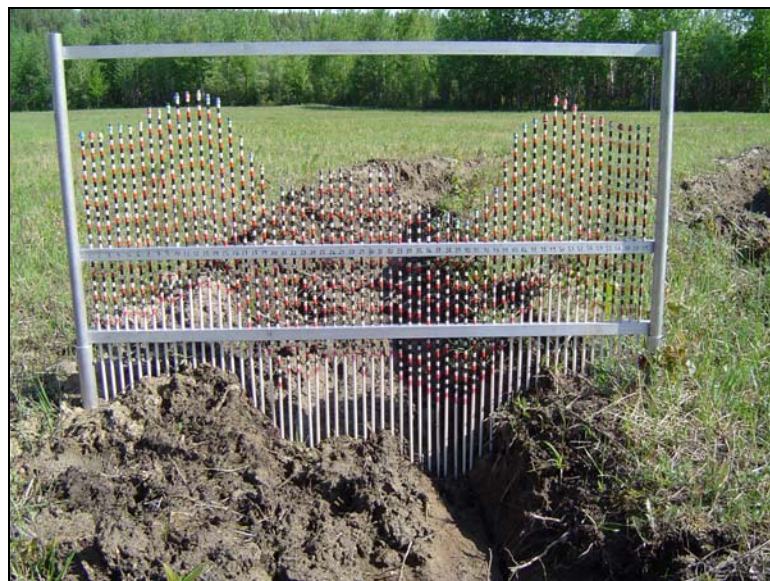
a. Left track.

b. Right track.

Figure A2. Rut profiles on point A8A on turn section of eight-pass at the Arkansas Range.

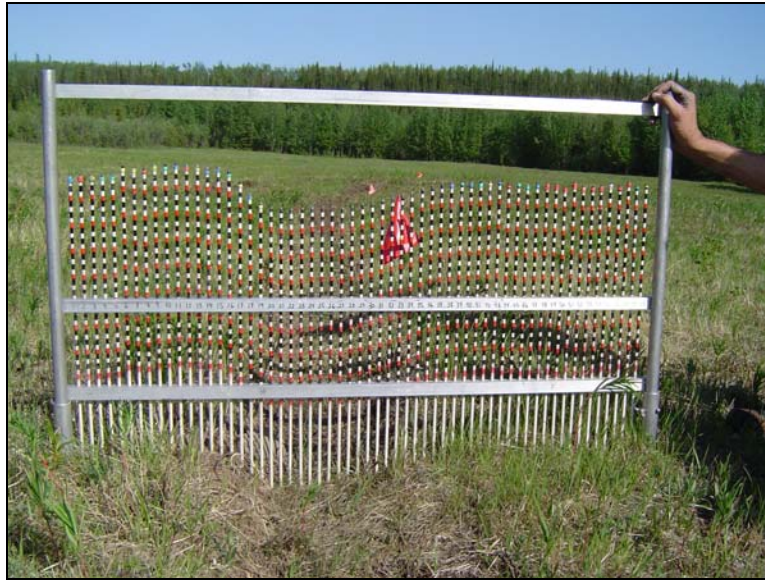
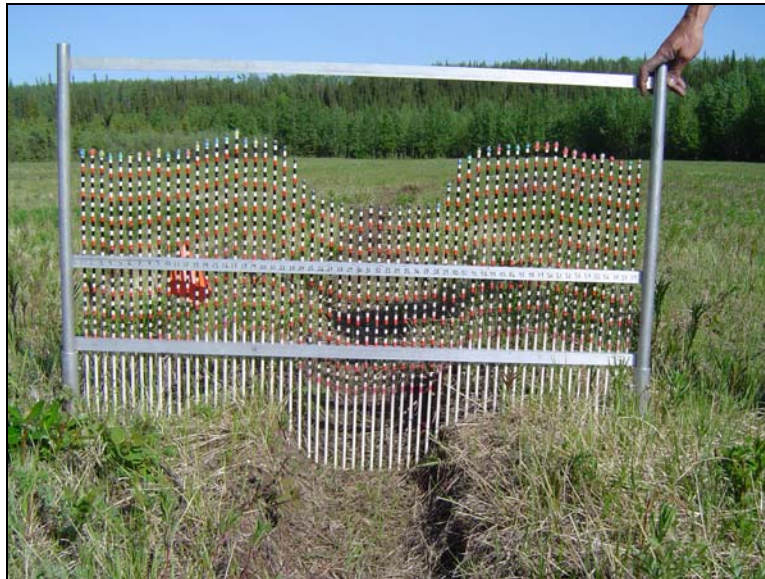
a. Left track.

b. Right track.

Figure A3. Rut profiles on point A4D on drier section of four-pass at the Arkansas Range.

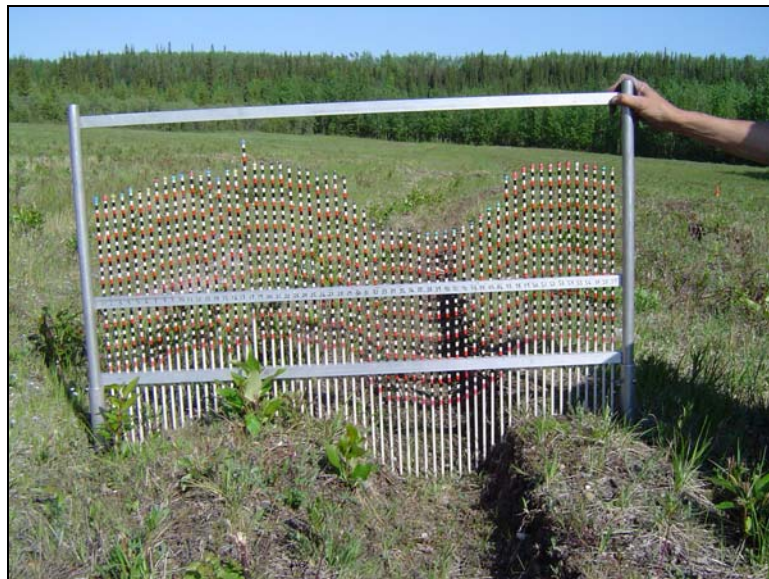
a. Left track.

b. Right track.

Figure A4. Rut profiles on point A1B on drier section of one-pass at the Arkansas Range.

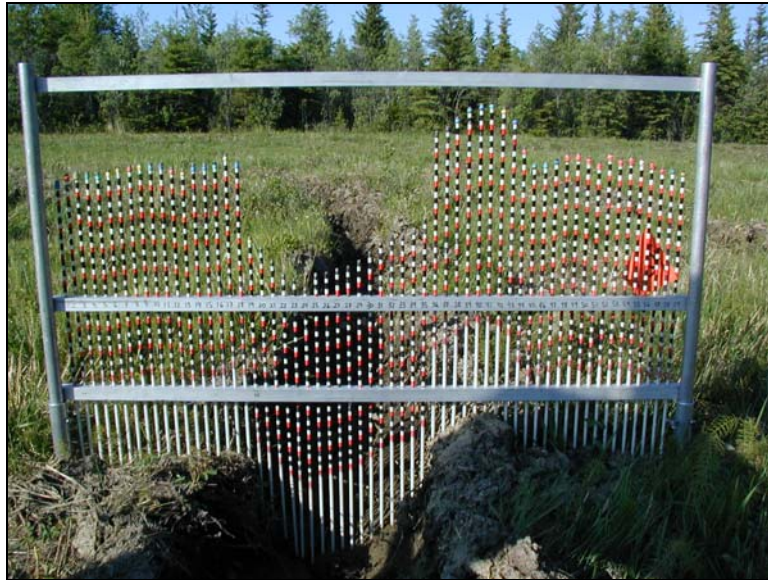
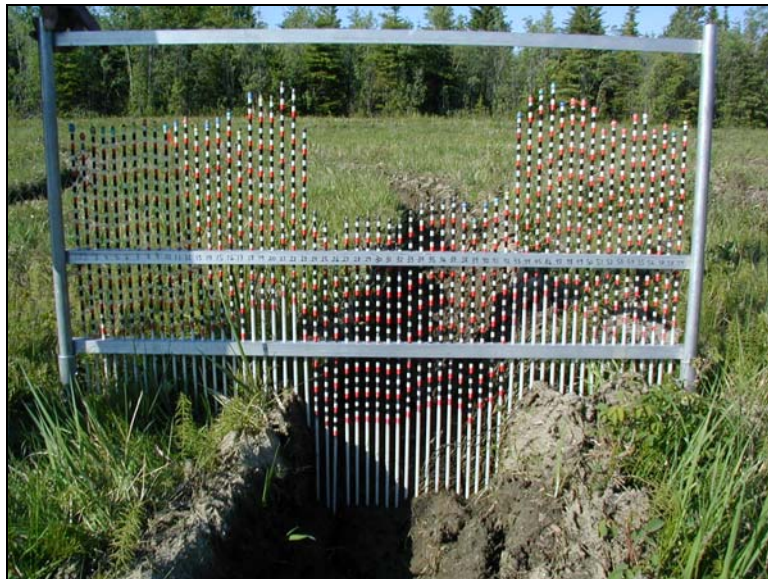
a. Left track.

b. Right track.

Figure A5. Rut profiles on point AS2B on spiral section at the Arkansas Range.

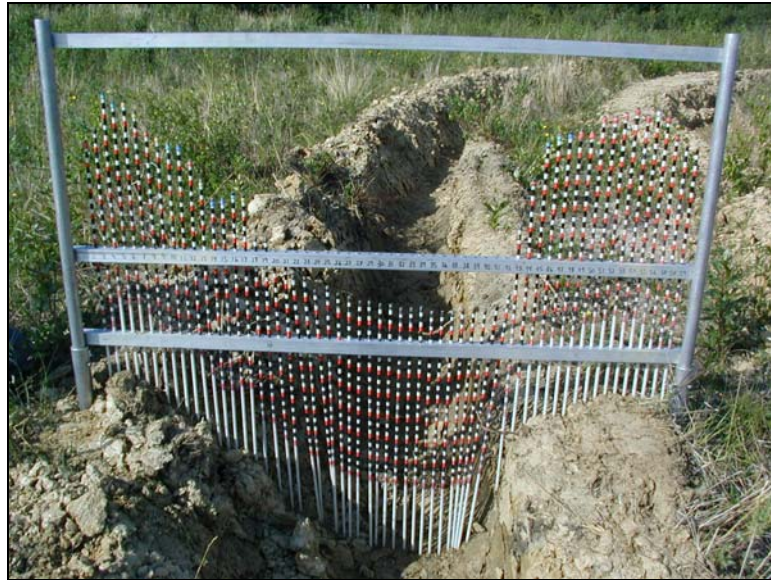
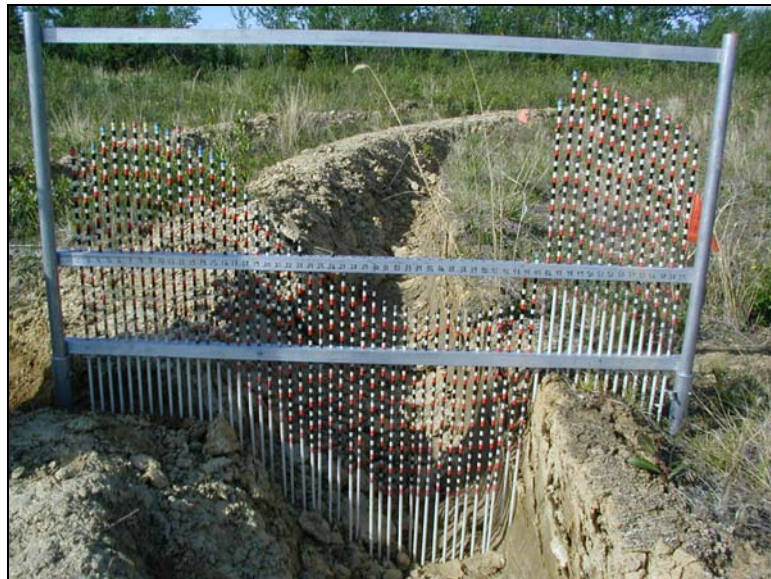
a. Left track.

b. Right track.

Figure A6. Rut profiles on point E13G on turn section of thirteen-pass at the Eddy Drop Zone.

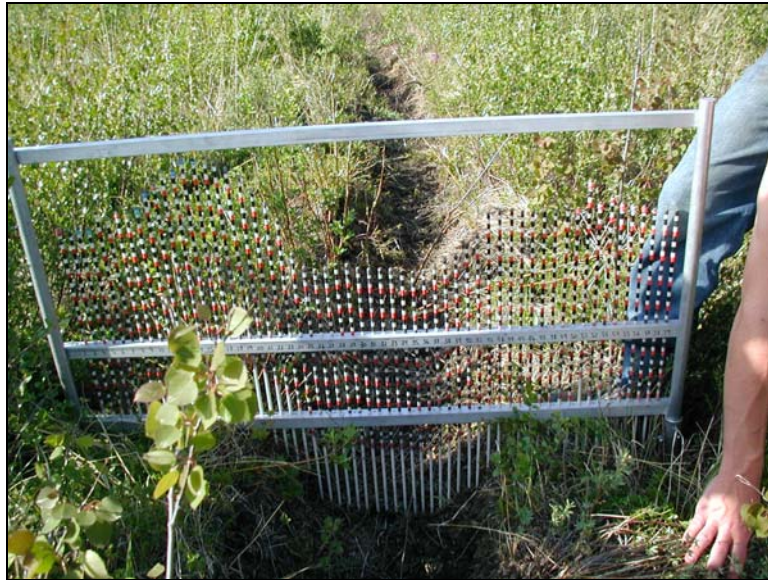
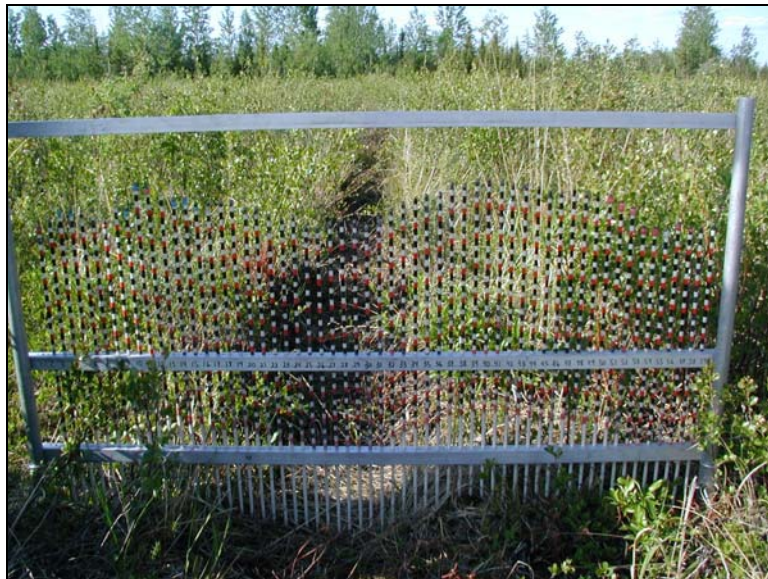
a. Left track.

b. Right track.

Figure A7. Rut profiles on point E4C on straight section of four-pass at the Eddy Drop Zone.

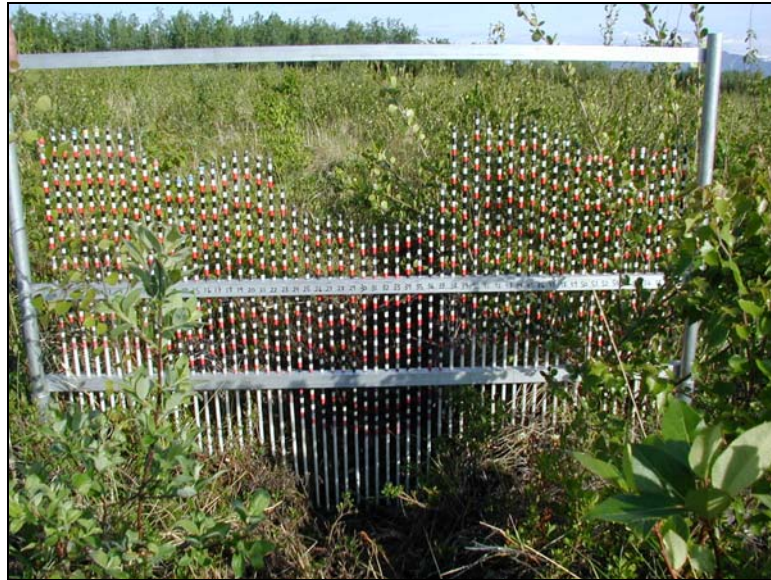
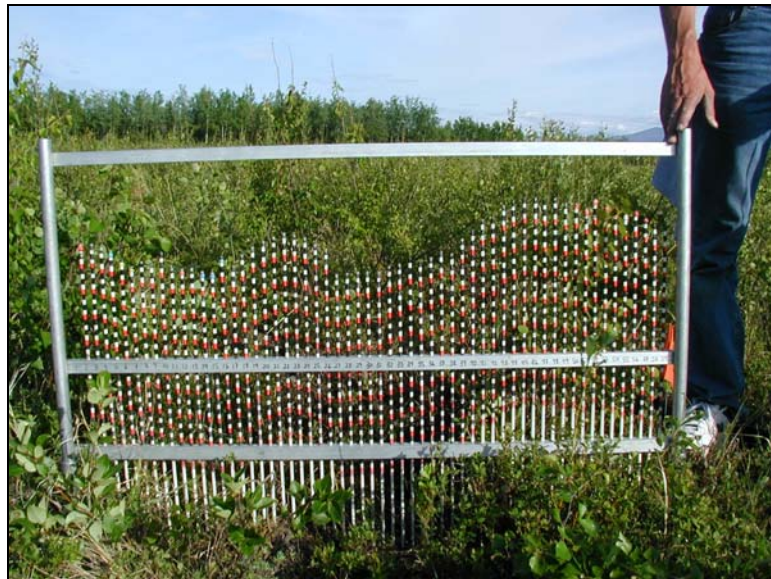
a. Left track.

b. Right track.

Figure A8. Rut profiles on point ES-2C on spiral section at the Eddy Drop Zone.
